Installation and Operating Instructions

Part Number 33CN-FLOAD

The FieldLoader V3.0 software allows easy upgrades of the operating software for VAV and Fan Powered Air Terminal controllers (Part numbers 33ZCVAVTRM and 33ZCFANTRM), Fan Coil controllers (Part number 33ZCFANCOL), and PremierLink™ Rooftop controllers (Part number 33CSPREMLK).

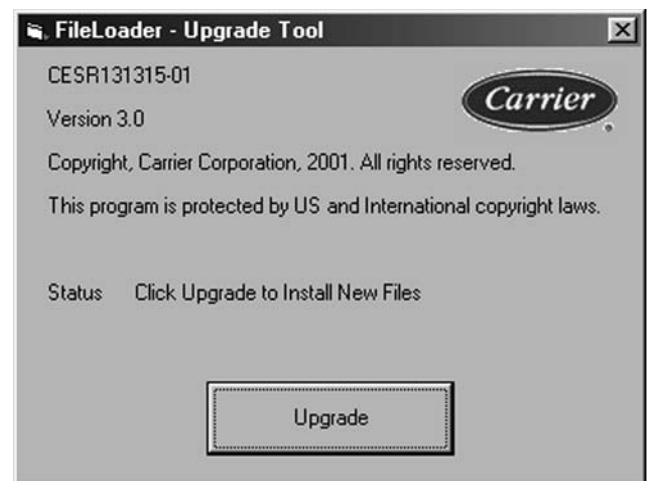
Fig. 1 — FileLoader Upgrade Tool

The FileLoader program is executed directly from the import disk of the new software version or from the files downloaded from the website. The new software version import disk or the files downloaded from the website will contain a FILELOADER.EXE file. The file will launch the FileLoader Upgrade Tool. See Fig. 1. Once the FileLoader upgrade tool has been launched, click on the UPGRADE button to import the new software version files into the FieldLoader software.

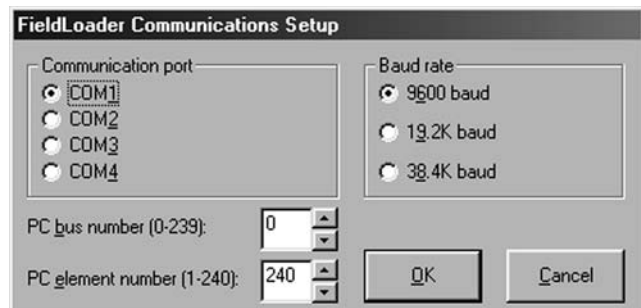
Fig. 2 — FieldLoader Communications Setup

Click on the SETUP button to access the FieldLoader Communications Setup screen. See Fig. 2. Select the proper communications port for CCN communications. Select the proper CCN baud rate. Specify the element number and bus number of the computer with the FieldLoader software.

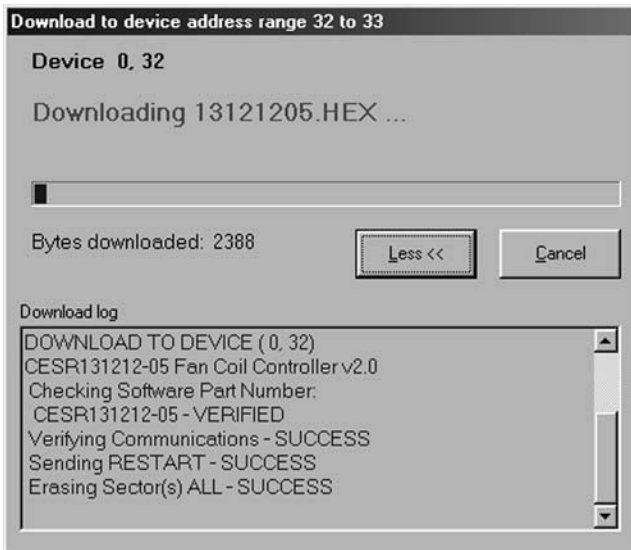
Fig. 4 — FieldLoader Download Screen

Once the proper Start and End Element numbers have been entered, press the REFRESH button in order to scan the element range entered. The scan will display all controllers found in the specified element range. Verify that the controllers found are the correct types and versions. Press the CONTINUE button to begin the upgrade process. A progress update will be displayed on the screen as the update occurs. Success and error messages will be displayed in the download log, which can be viewed by using the MORE button on the download progress screen. See Fig. 4.

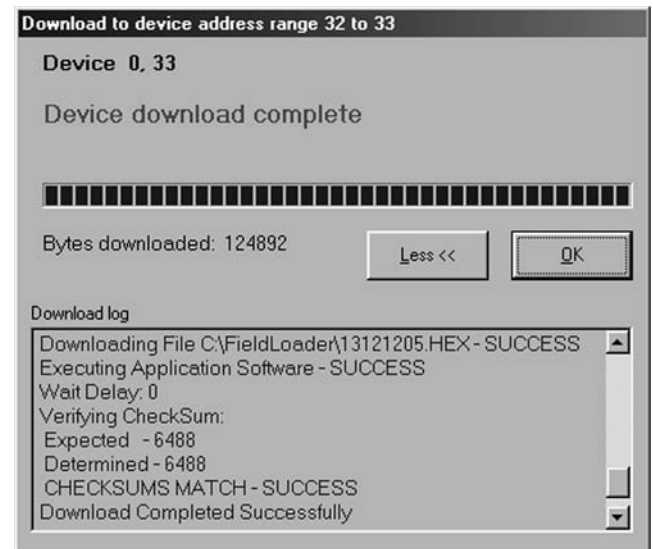
Fig. 5 — Sample Download Log

Once the download is complete, the MORE button on the screen can be utilized to view the current download log. See Fig. 5. Also, after upgrading the controllers, the download log can be saved as a text file (this is optional).

The download log contains useful information that can be utilized in the event of a download failure. Unsuccessful downloads will display the reason the download failed. Failure messages include: “unable to verify software version,” “unable to communicate to controller,” and “checksum failure.” More information regarding error messages is given in the Troubleshooting section on this page.
